Photographs: ASH – Hospital Administration, Canteen, Nursing Administration and Admissions Buildings

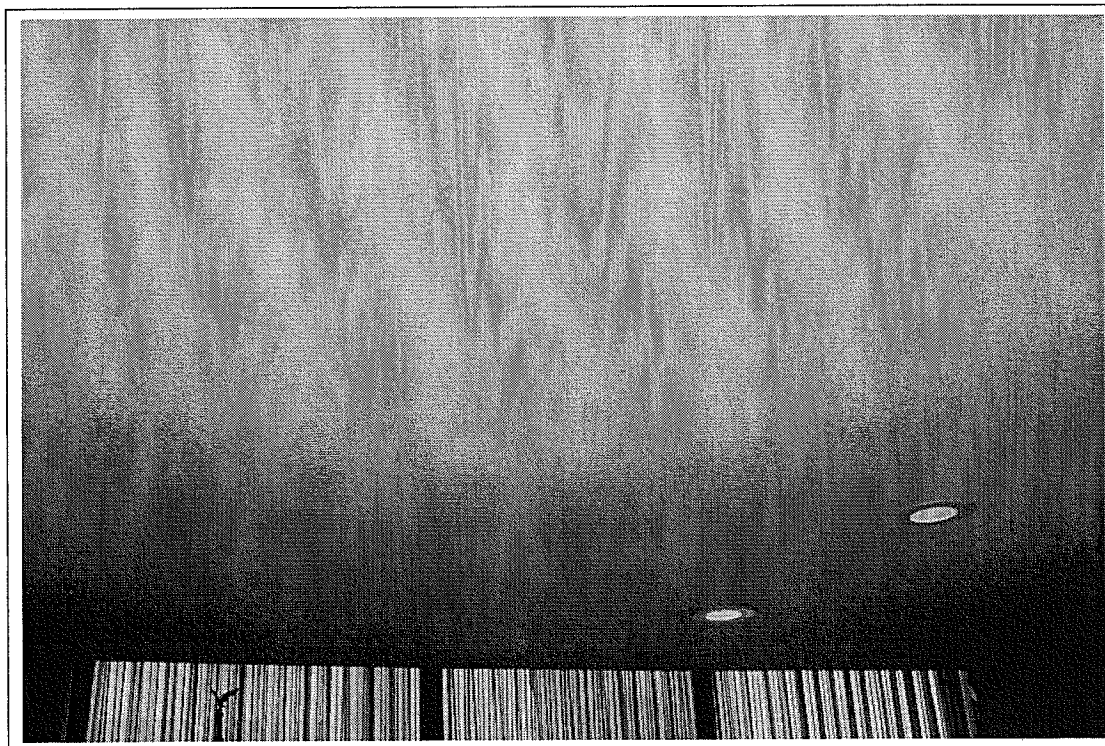
Photo 33. Hospital Administration Bldg. 1st floor visitors lounge area - General view of impact damage to acoustical plaster in lobby

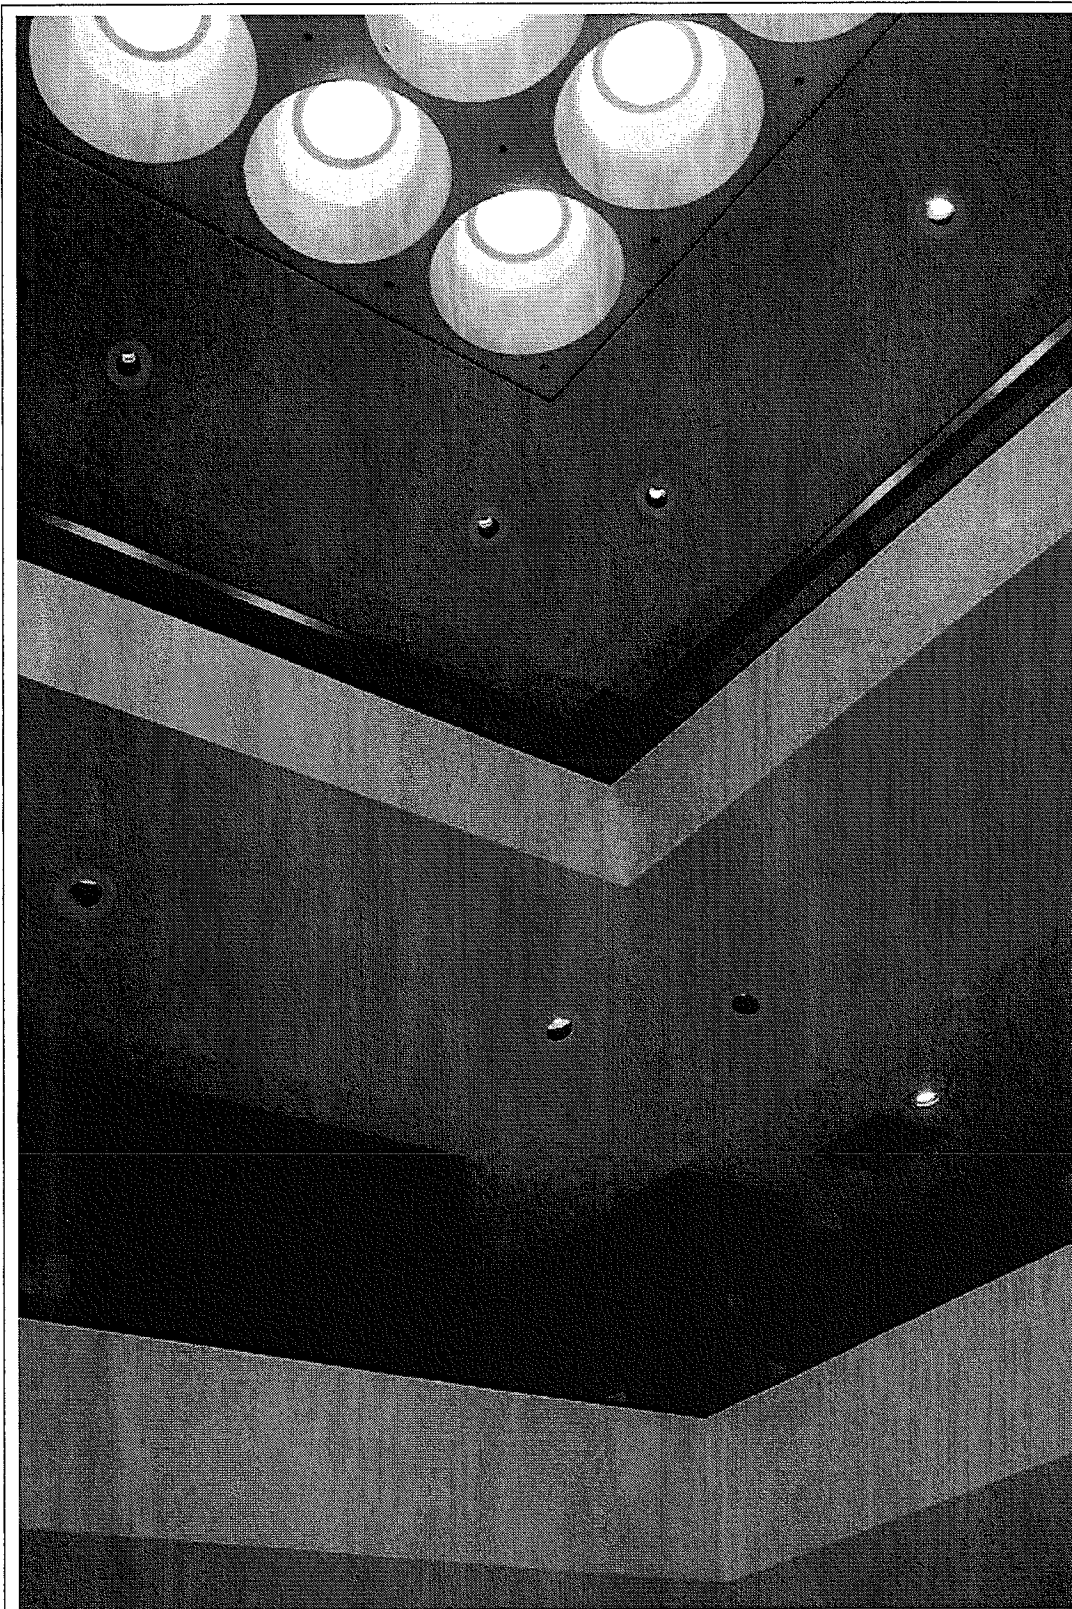
Photo 34. Hospital Administration Bldg. 1st floor visitors lounge area - General view of acoustical plaster in atrium lobby/visitors lounge area

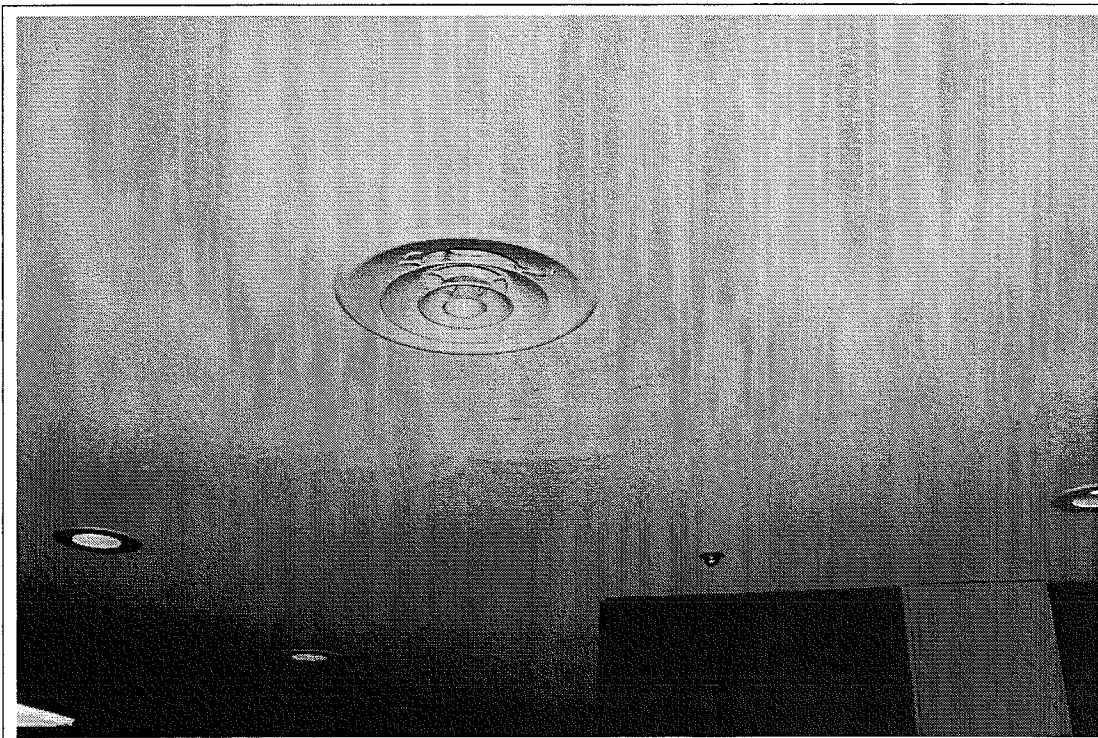
Photo 35. Hospital Administration Bldg. 1st floor visitors lounge area - View of water damaged acoustical plaster next to ceiling diffuser

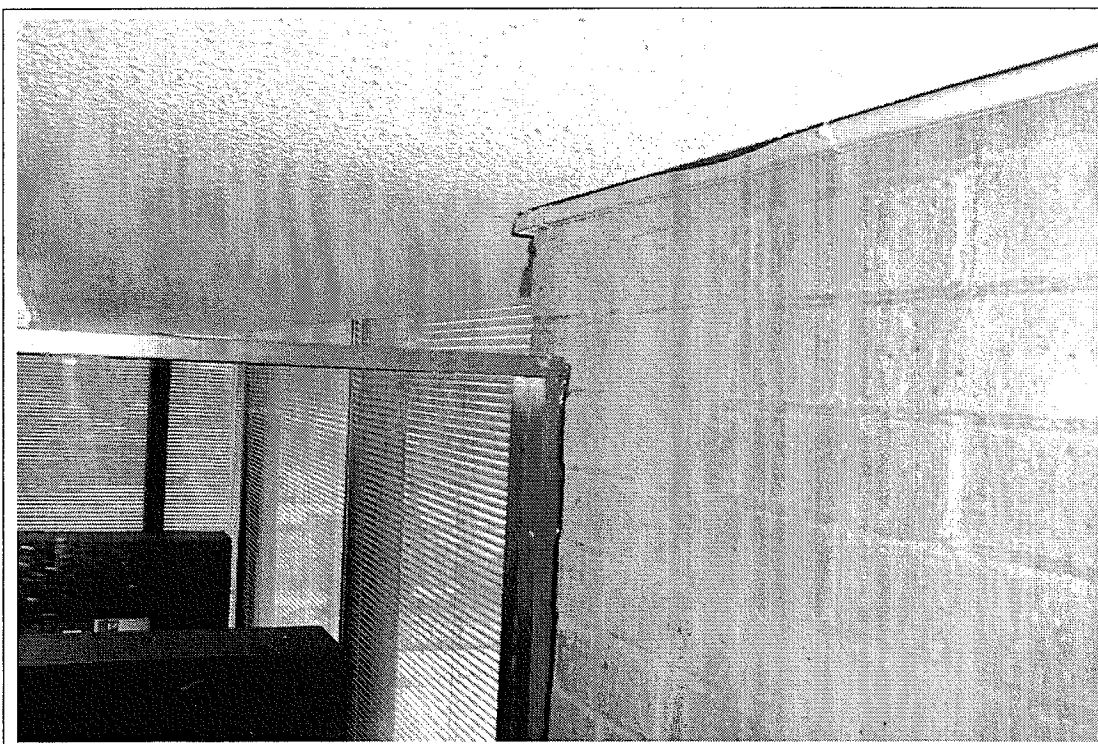
| Sample # | Sample Date | General Sample Location | Sample Surface | Asbestos Structures Counted | Asbestos (Conc.) Str/Ft <sup>2</sup> | Asbestos (Conc.) Str/Cm <sup>2</sup> | Relative Contamination Level |
|---|---|---|---|---|---|---|---|
| 2 | 9/7/2006 | ASH Admin 1st floor | top of window ledge | 34 | $3.96 \times 10^7$ | $4.26 \times 10^4$ | Moderate |

Photo 36. Hospital Administration Bldg. 1st floor SW hallway - Acoustical plaster above door to staff development office (general location of dust sample #2 - top of door frame)

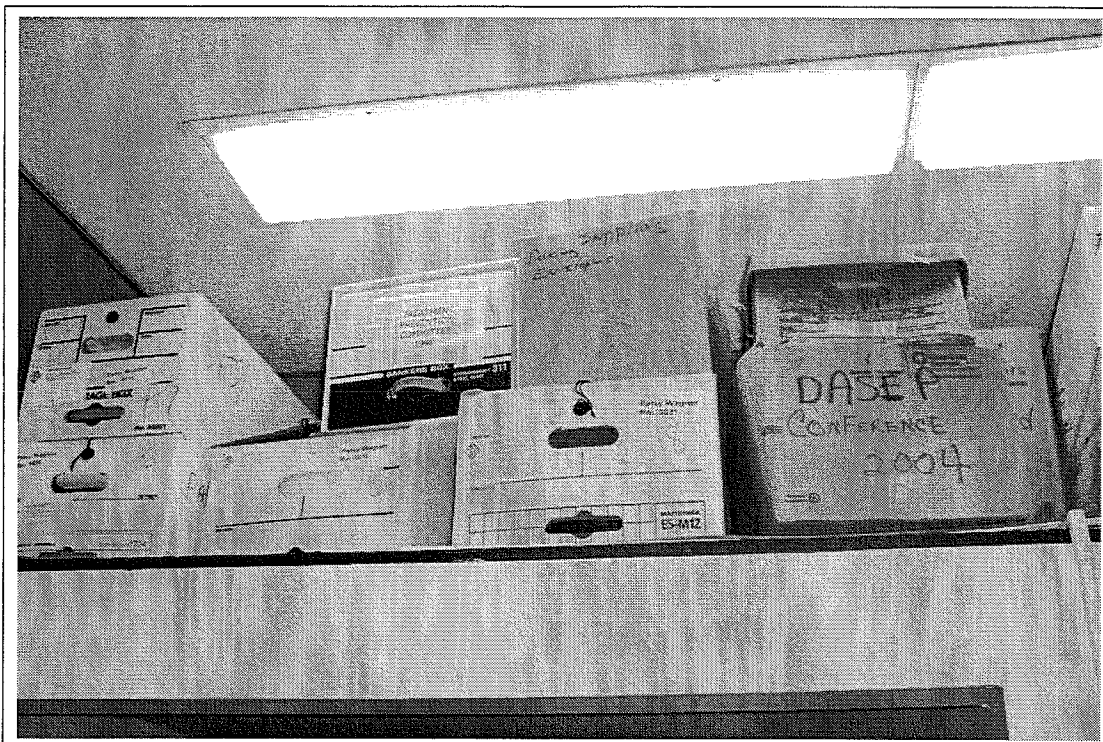
| Sample # | Sample Date | General Sample Location | Sample Surface | Asbestos Structures Counted | Asbestos (Conc.) Str/Ft <sup>2</sup> | Asbestos (Conc.) Str/Cm <sup>2</sup> | Relative Contamination Level |
|---|---|---|---|---|---|---|---|
| 3 | 9/7/2006 | ASH Admin 3rd floor - Alcohol & Drug Office | top of storage shelf | 103 | $2.03 \times 10^9$ | $2.18 \times 10^6$ | Extreme |

Photo 37. Hospital Administration Bldg. 3rd floor Alcohol & Drug Abuse Office – Location of dust sample #3 – top of wood storage shelf beneath acoustical plaster finish

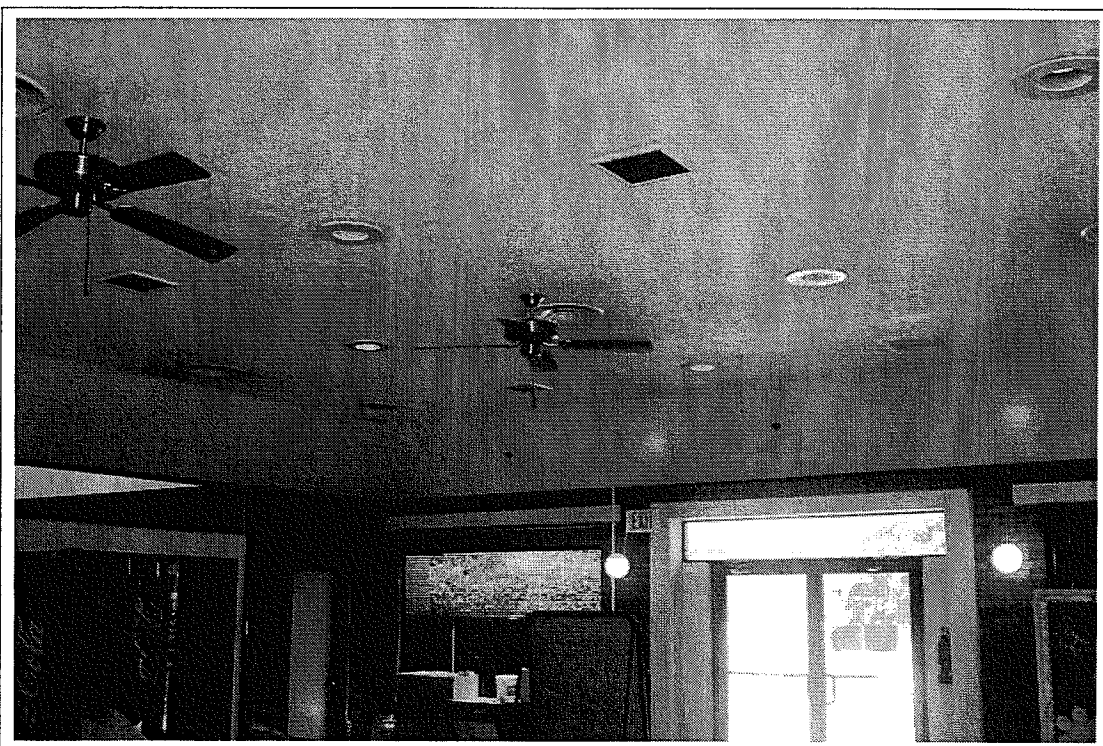
Photo 38. Canteen Bldg. Dining Area - General view of acoustical plaster ceiling above dining tables
